Vulnerability of Some Juneau School District Schools to Earthquake Damage Based on Rapid Visual Screening

June 15, 2018

Prepared for: Juneau School District and
Alaska Seismic Hazards Safety Commission
Administered by: The Earthquake Engineering Research Institute
Funded by: Federal Emergency Management Agency

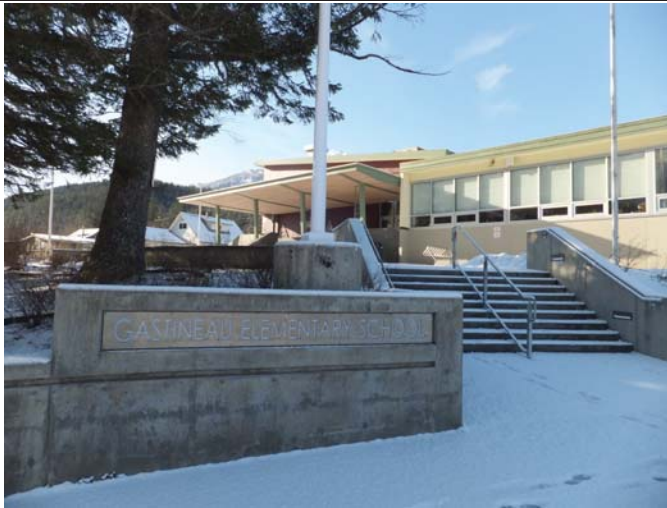
Adjacency: ☒ Pounding ☐ Falling Hazards from Taller Adjacent Building

Exterior Falling Hazards: ☒ Unbraced Chimneys ☐ Heavy Cladding or Heavy Veneer
☐ Parapets ☐ Appendages
☐ Other: _____

Are There Hazards That Trigger A Detailed Structural Evaluation?
☒ Pounding potential (unless $S_{L2} >$ cut-off, if known)
☒ Falling hazards from taller adjacent building chimney
☐ Geologic hazards or Soil Type F
☐ Significant damage/deterioration to the structural system

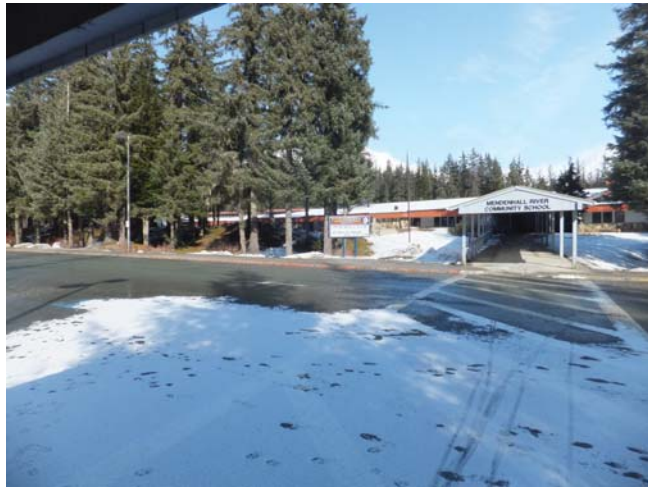
Covered entry walkway could be both a pounding and a falling hazard. It was set directly against the existing building yet without connection to it, and it utilizes a wood post moment frame that appears to have very limited capacity.

☒ Falling hazards from taller adjacent building entry canopy

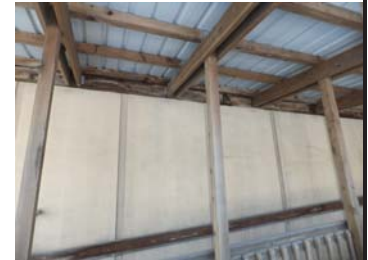
The rear ramp for handicap access and its canopy fasten to the building, but the fasteners making up the lateral load path aren't visible, nor do they appear in the available drawings. Stability of the ramp and canopy should be confirmed.
