Identifying Potential Earthquake Dangers To Alaska's Students and Schools

A Pilot Project Screening Matanuska-Susitna School District Buildings February 6, 2015

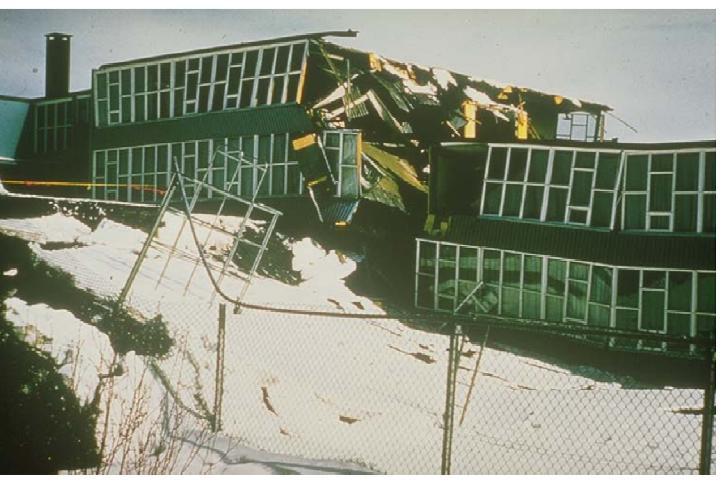
Government Hill Elementary School after the 1964 Earthquake

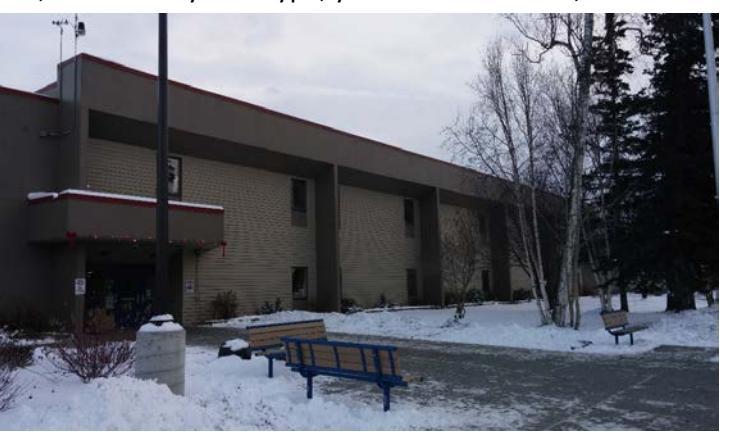
Cottonwood Creek Elementary School

- no additional review is indicated
- 5) Cottonwood Creek Elementary School: 1981
 - Wood construction
 - Final score = 4.8; FEMA estimate of collapse risk: 0.002%

- no additional review is indicated

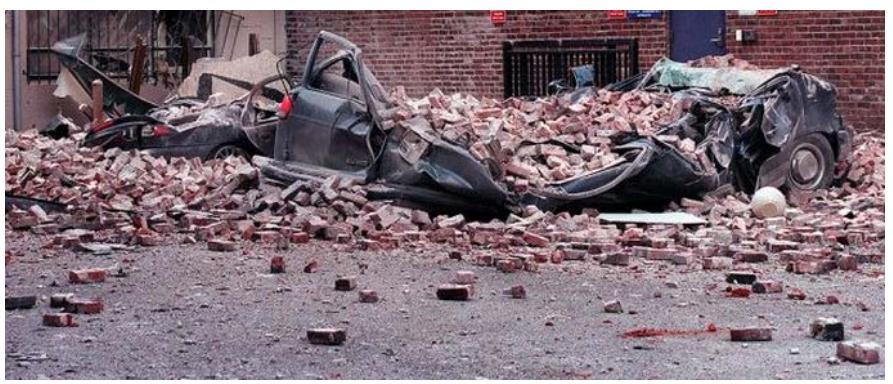
Nisqually earthquake damage at a building without seismic retrofit

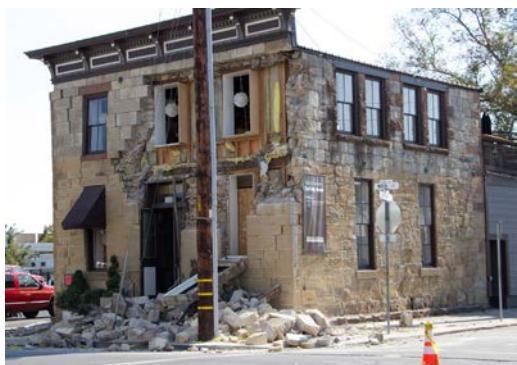
Napa earthquake damage to a building without seismic retrofit
