Vulnerability of Some Juneau School District Schools to Earthquake Damage Based on Rapid Visual Screening

June 15, 2018

Prepared for: Juneau School District and
Alaska Seismic Hazards Safety Commission
Administered by: The Earthquake Engineering Research Institute
Funded by: Federal Emergency Management Agency

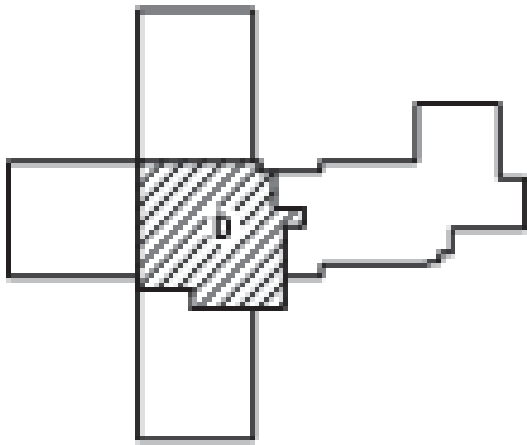
Irregularities: ☒ Vertical (type/severity) Moderate: split level
☒ Plan (type) Reentrant corners
