Identifying Potential Earthquake Dangers To Alaska's Students and Schools

A Pilot Project Screening Matanuska-Susitna School District Buildings February 6, 2015

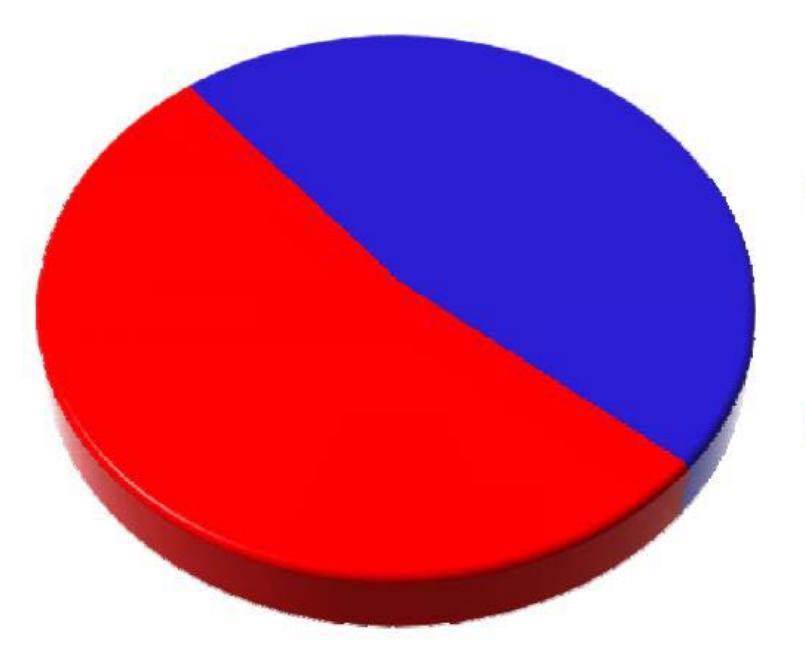
Schools Considered Safe (Less than 1% Chance of Collapse)

Schools with Unacceptable Seismic Risk (Greater than 1% Chance of Collapse)
