**GREATER ANCHORAGE AREA
EARTHQUAKE RESPONSE STUDY
1980**

**Prepared By
Alaska Division of
Emergency Services
Contract DU210-2**

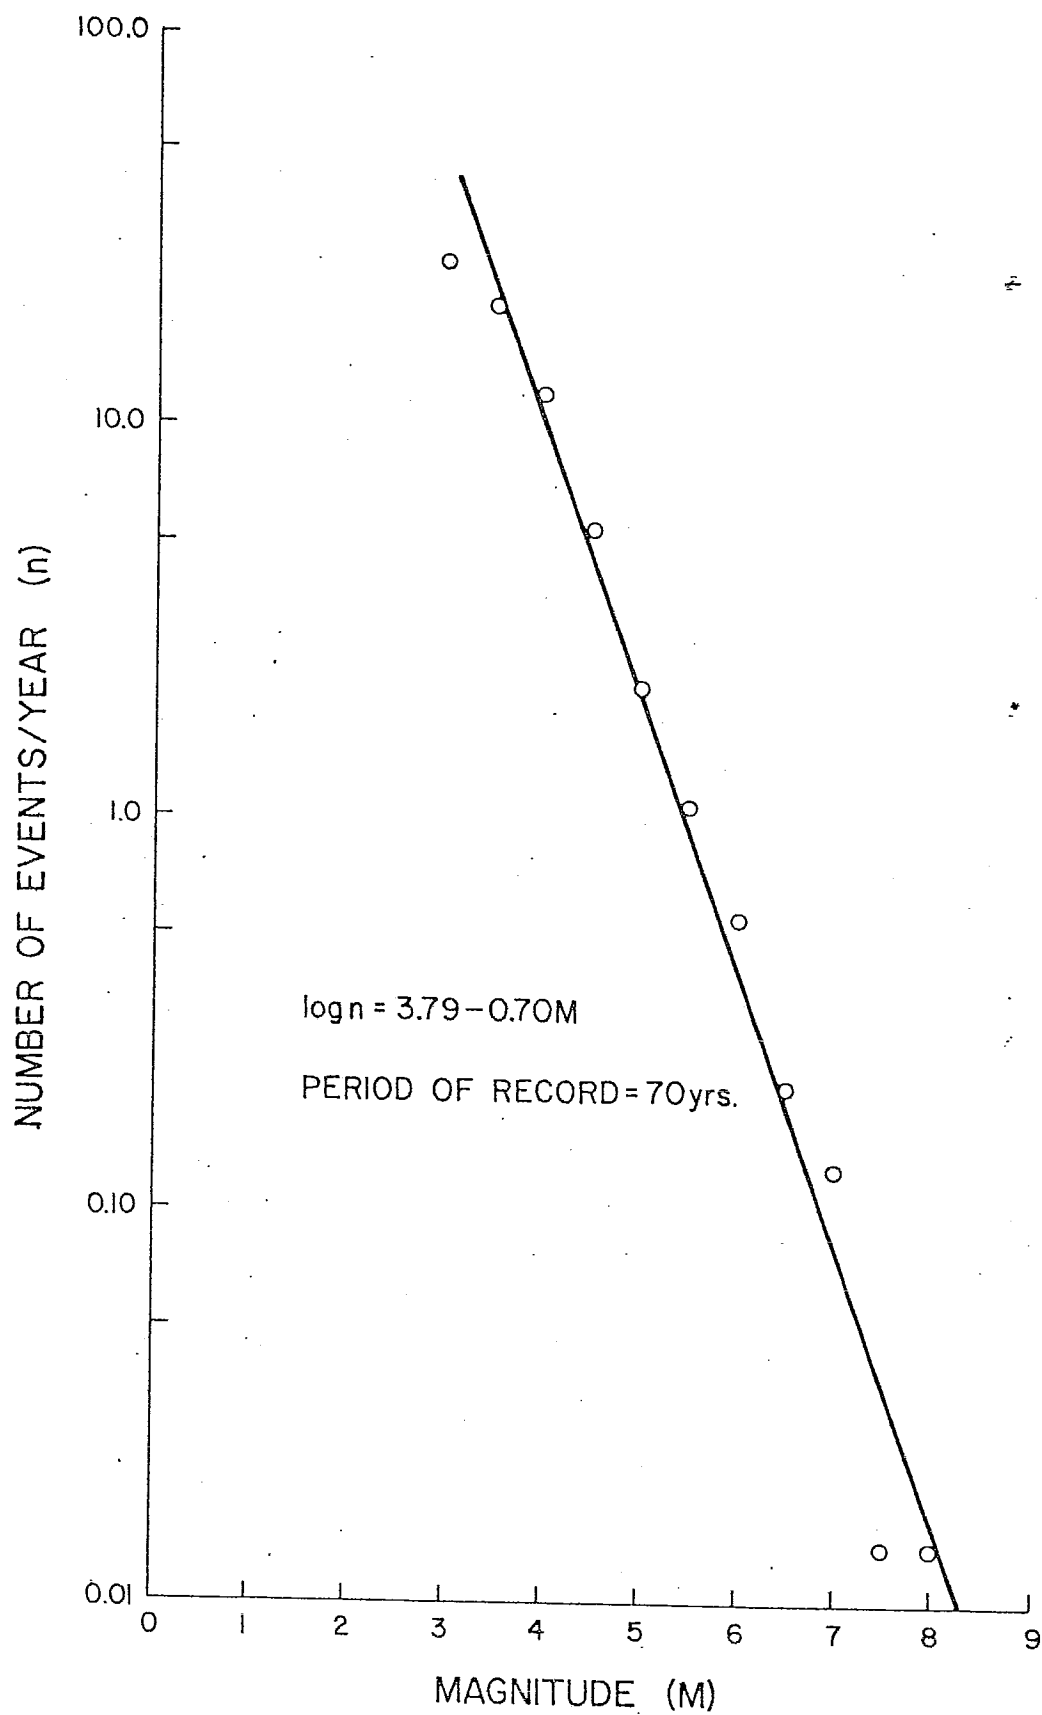
FIGURE 7

CUMULATIVE MAGNITUDE
FREQUENCY RELATIONSHIP (ANCHORAGE REGION)

The historic seismicity of this region was analytically described according to the relationship proposed by Richter (1958).

$$\log n = a - b M$$
