Vulnerability of Some Kenai Peninsula Borough Schools to Earthquake Damage Based on Rapid Visual Screening

December 1, 2015

Prepared for: Kenai Peninsula Borough School District & Alaska Seismic Hazards Safety Commission Administered by: The Earthquake Engineering Research Institute Funded by: Federal Emergency Management Agency

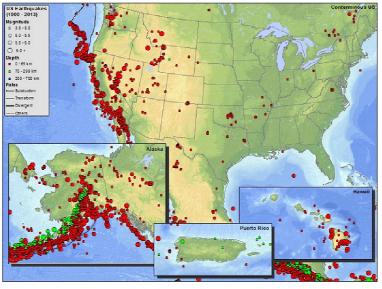
Sites of major earthquakes in the US (USGS)

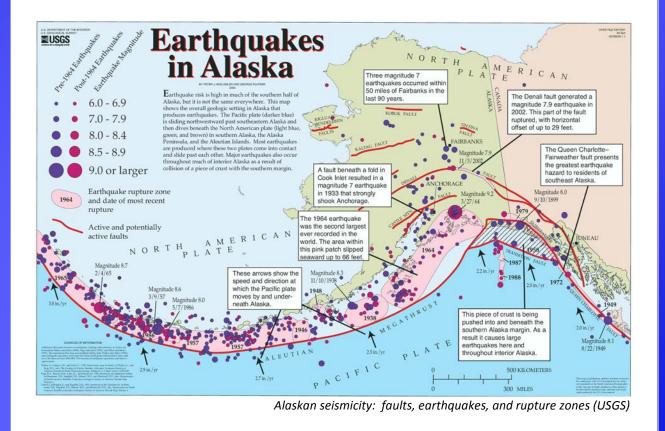
3-D Model of the Aleutian Megathrust sliding below the North American Plate (USGS)

Alaska's intense seismicity is a result of plate tectonics. The Pacific Plate, moving north 2" to 3" per year, slides below the North American Plate at a fault called the Aleutian Megathrust. This tectonic collision and subduction is able to produce an earthquake up to magnitude 9.2, according to the Federal Emergency Management Agency (FEMA). Many other faults occur around the state, and though earthquakes associated with them are not as powerful, they may govern the nearby ground accelerations because of their close proximity.
